Failure Analysis of Cracked Auto Mirrors

Failure Analysis: Manufacturing Engineer Examines the Root Cause of Automobile Rear View Mirror Failures

The root cause of the failure of customer returns of heated automobile rear view mirrors was investigated.

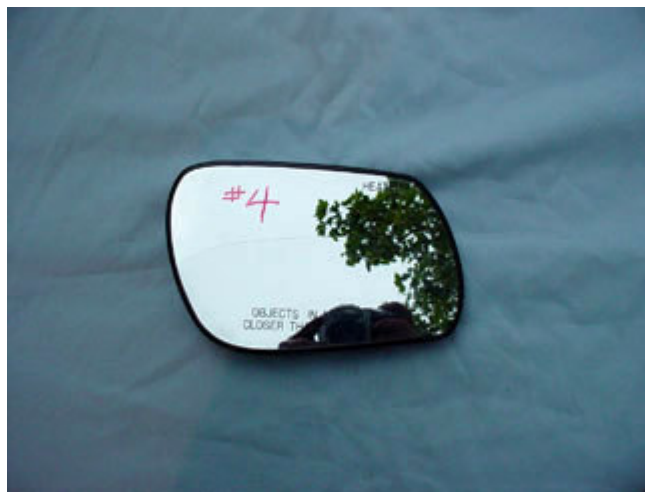
Analysis: A failure analysis was performed on samples of these mirrors to determine the cause of failure. Figure #1 is a sample of a failed mirror. It has a horizontal crack in the middle that goes across the entire mirror.

Figure #1: Photograph of a representative cracked mirror. The horizontal crack traverses it just below the "4".

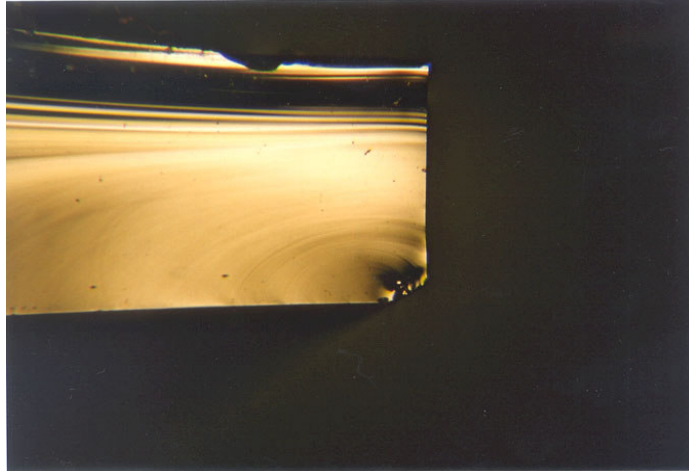
The failure analysis reveals that this failure resulted from a "crush" that occurred at the scribe "start" point (Figure #2). Because the height of the curved mirror surface is variable, the scribe wheel hits the surface too hard in some instances.

Figure #2: Photo micrograph of a typical crack initiation point. The crack originated at a crush point seen on the lower right corner. The coated side of the mirror is on the bottom right of the mirror in the photograph (Mag. 30X).

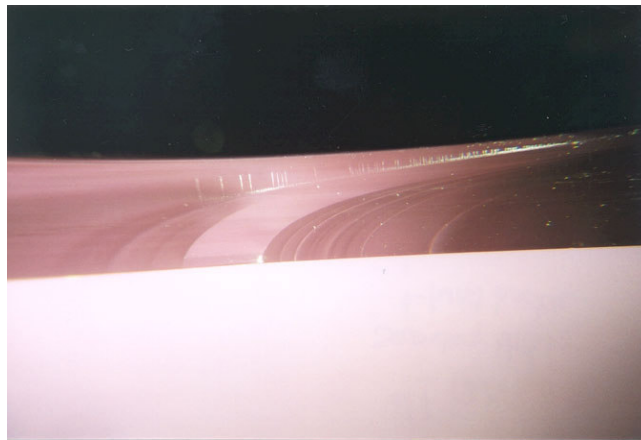
Figure #3: Photo micrograph some of the Wallner lines on the same crack shown in Figure #1.. The crack travels from right to left The coated side of the mirror is on the bottom of the photograph (Mag. 20X).

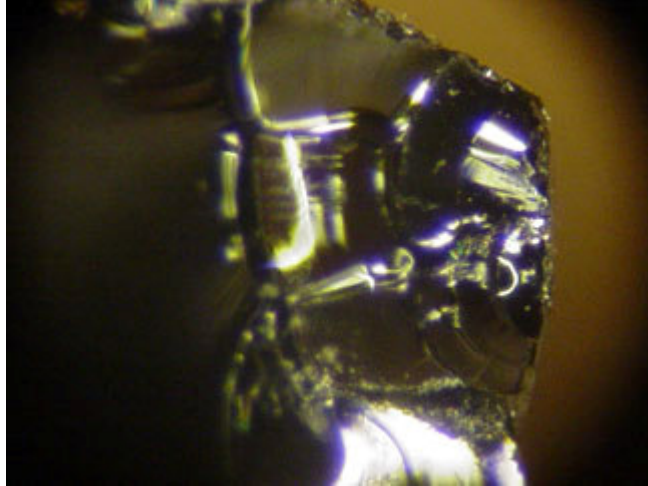
Figure #4: Higher magnification photo micrograph of a representative crush found at the failure origin (Mag 200X)

Conclusion: The cracking of these rear view mirrors was caused by a "crush" caused by the scribe wheel when it started the scribing process.

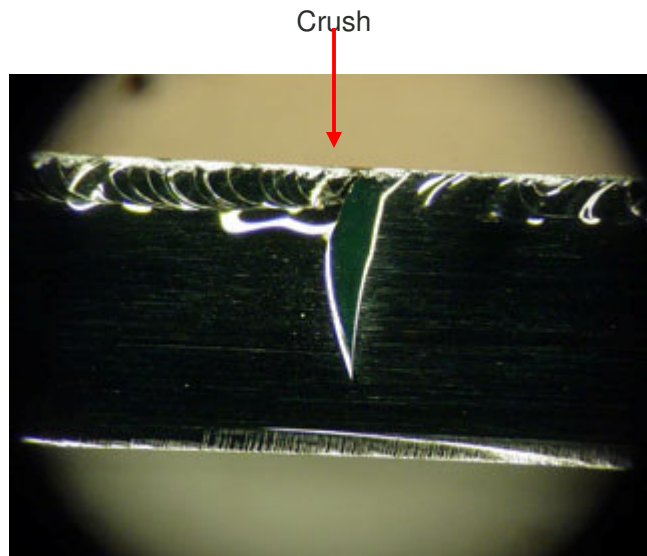
Figure #5: Start point on a mirror that shows a crush at the top of the starting point. The starting point is on the top of the "winged" shaped crack in the middle of the picture (Mag 30X).

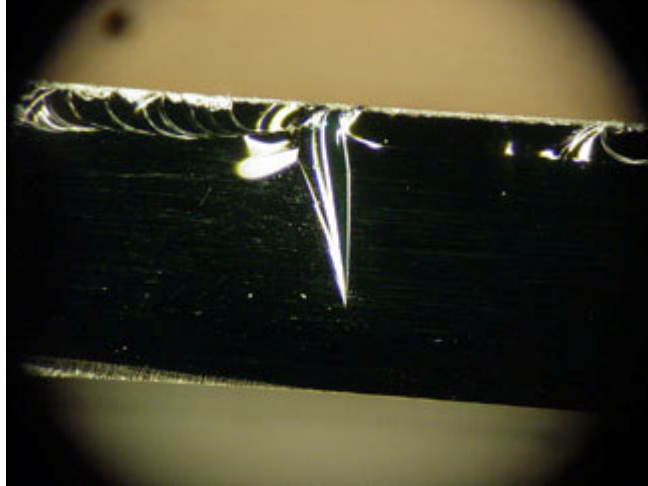
Figure #6: Start point on an a mirror that has no crush at the top of the starting point. The starting point is on the top of the "winged" shaped crack in the middle of the picture (Mag. 30X).
