Failure Analysis of Glass Cookware

Glass Expert Performs Glass Failure Analysis of Glass Pie Plate

Introduction: A glass pie plate was being used to melt caramel. When being removed from the oven, it fractured and injured the user.

Objective: Perform a failure analysis to determine the root cause of the fracture.

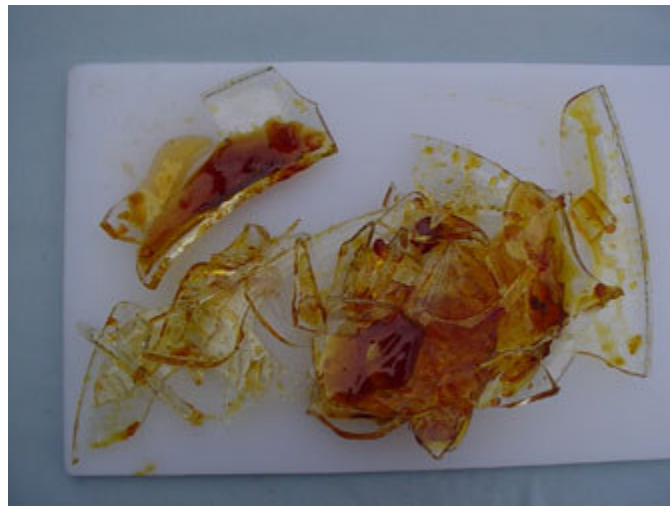
Figure #1: Broken glass dish in the as received condition. All the pieces are covered with the hardened caramel.

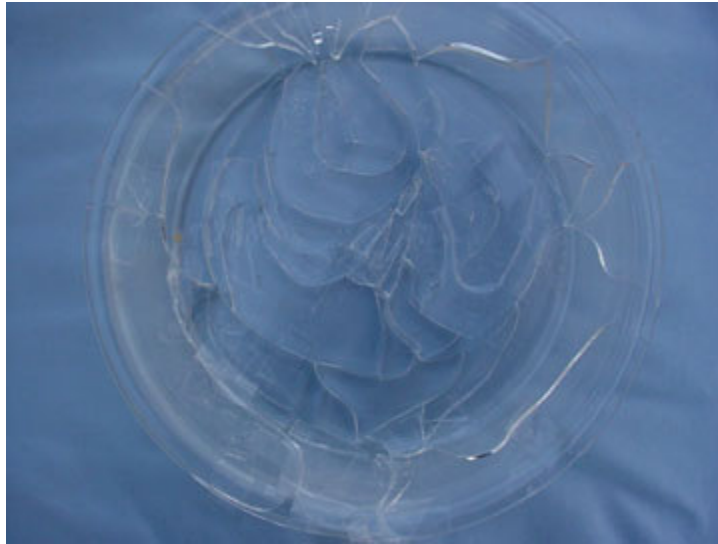
Figure #2: Photograph of the re-assembled dish. The failure origin is at the top of the photo. The "wandering" nature of the cracks leaving the origin indicates that the failure was driven by thermal stresses.

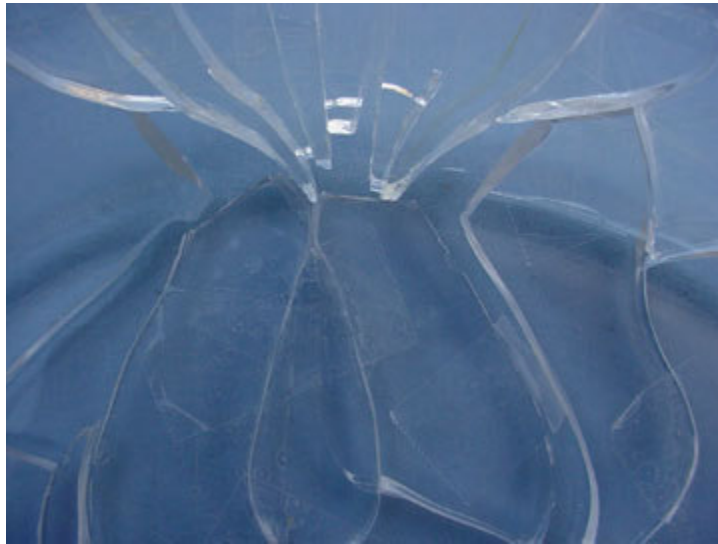
Figures 3 through 5 summarize the findings. The root cause of the failure was an oval shaped defect inside the glass.

Figure #3: Close-up of the region of the fracture origin.

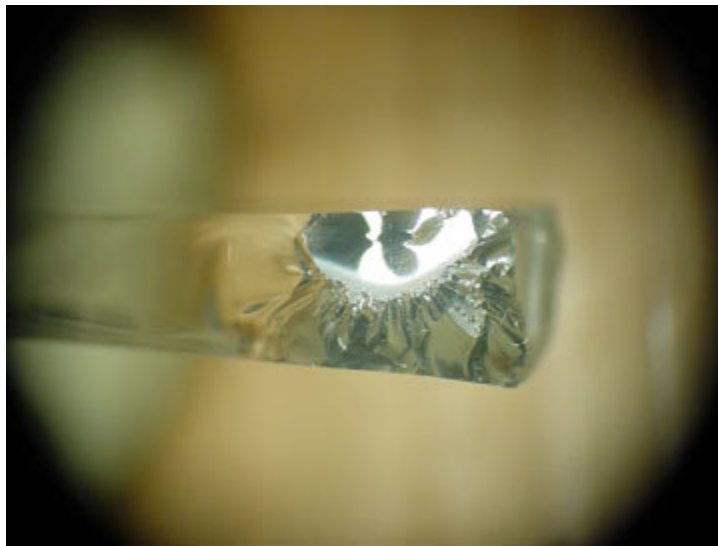
Figure #4: Low power micrograph of the failure origin. This failure originated in the interior of the glass (Mag. 12X).

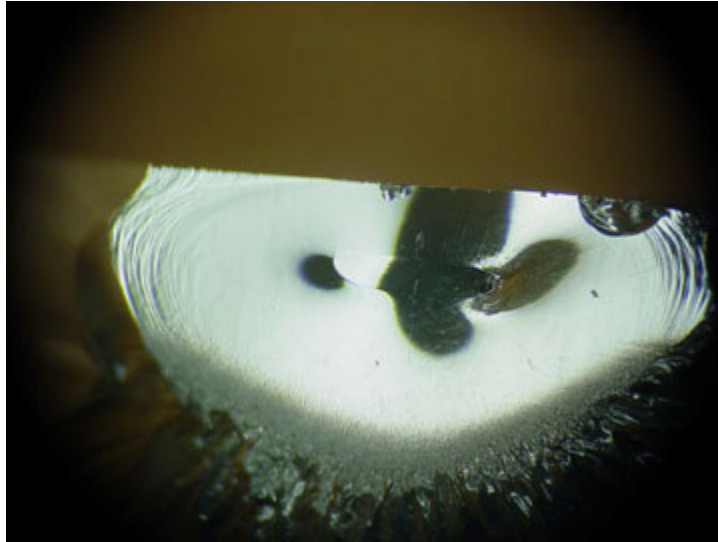
Figure #5: Low power micrograph of the failure origin. This failure originated in the interior of the glass. The Wallner lines emanate in all directions from an oval shaped defect. It appears that the defect is a collapsed bubble (seed) that did not "re-weld" (Mag. 40X).

Conclusion: The failure was a thermal crack that initiated at a flaw in the glass. The flaw appears to be a collapsed bubble in the glass. This is a manufacturing defect.

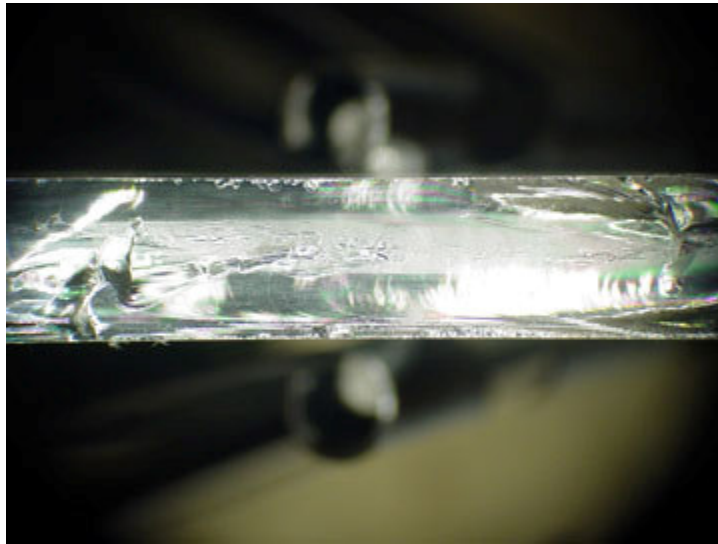
Additional Observation: There was a "cluster" of straight cracks. The fracture surfaces indicated that they were in regions where the glass surface compressive stresses in tensile stresses in the center (See Figure #6).

Figure #6: Photomicrograph of the type of fracture surface found on the straight cracks. The mist hackle in the center indicates significant tensile stresses in the center of glass. In addition, there are two sets of Wallner lines. This is similar to a "tempered glass" fracture surface, This crack traveled from right to left (Mag. 20X).
