**Read Consulting LLC
1435 Fulton Rd.
Santa Rosa, CA 95403
Tel: 707-544-2374
www.readconsulting.com**

Failure Analysis of a Failed Ceramic Water Holding Tank on a Toilet

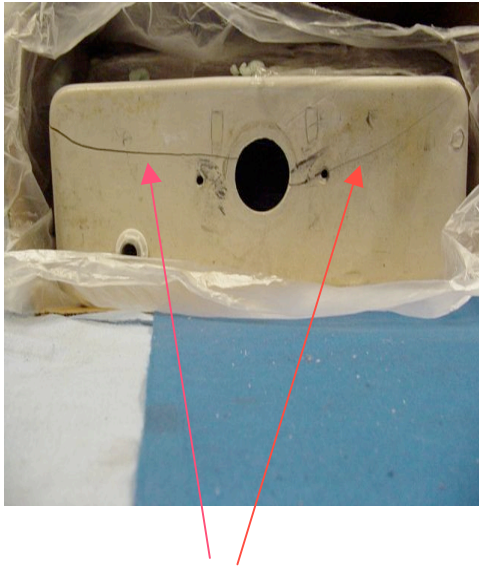
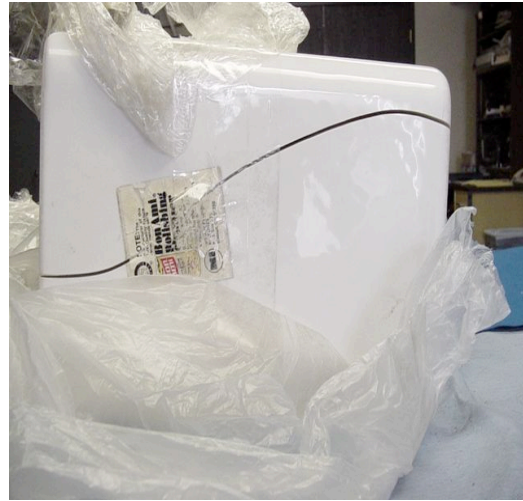
Main Crack

View from the Tank Bottom

View from the Tank Front

Figure #1: Two views of the failed tank. The main crack runs from the top of the tank on the right side (in a frontal view) across the bottom and partially up the left side. This crack also ran through the hole for the right hold down bolt and through the large “drain” hole in the center of the tank. Because the tank was still intact, the fracture surfaces were hidden, and a complete failure analysis could not be performed.

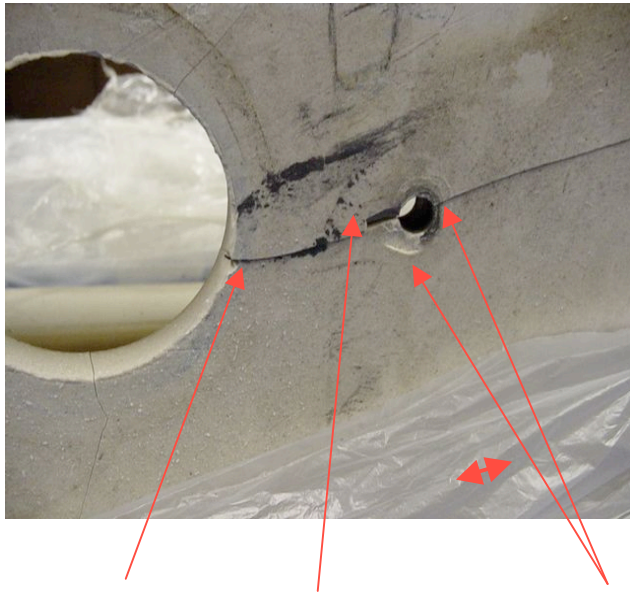
- 1. It appears as if a hacksaw was used to cut the two hold down bolts.**
- 2. There was a piece of rubber pinched in the main crack on the right side of the drain hole.**
- 3. There is evidence that a metal washer had damaged the bottom of the tank around the right side bolt hole. This indicates that this toilet was assembled with a nut and washer on the underside of the tank. This is not normally done.**
- 4. There are several other cracks (unfinished) around the drain hole.**

Note: The presence of washer damage on the outer bottom of the tank indicates that an attempt was made to stop the leaking by trying to squeeze the inner rubber washer assembly with an external nut and washer.

“Pinched Rubber” Saw Blade Marks Circular Washer Damage

Figure #2: Close-up of the right bolt hole and right side of the drain hole.

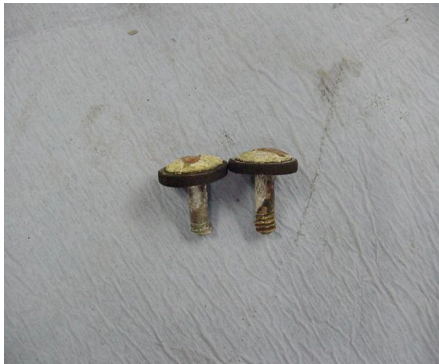
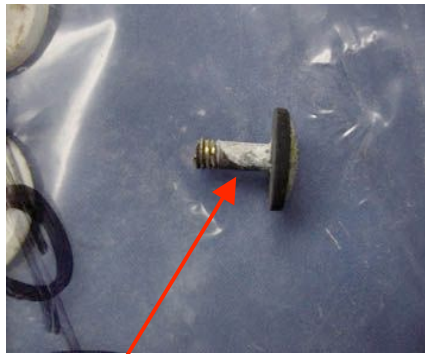
5. There are staining and chipping around the right side bolt hole.
6. Both hold down bolts have what appear to be calcium deposits. This indicates that there were leaks occurring at both hold down locations.

What appears to be calcium deposits

Figure #3: Photograph of what remains of the two hold down bolts. Both appear to have calcium deposits on them. This indicates that the holes were leaking.

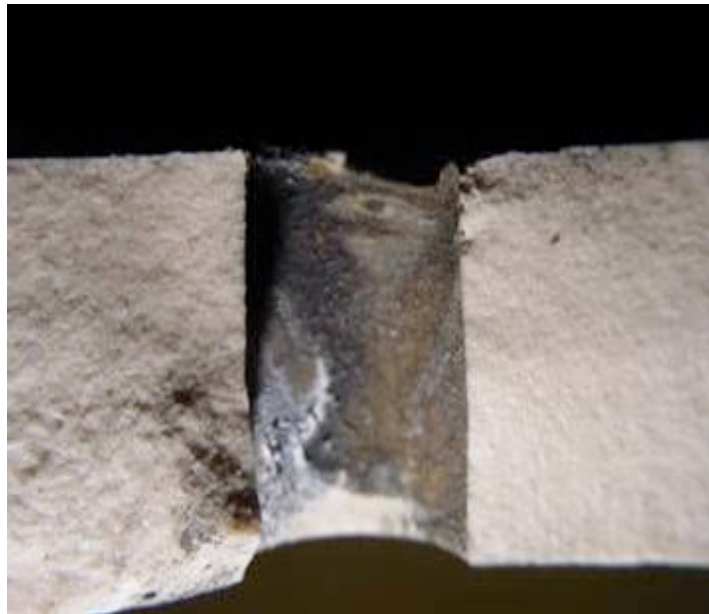
Calcium Deposit

Crack Initiation Site

Figure #4: One view of the fracture surfaces at the right hand hold down hole. For this photo the light angle was chosen to reveal a series of crack arrest lines from a crack starting on the inside of the tank. These are on the right *side of the hole*. In addition, there is staining in this region. This indicates that this initial crack existed long before the failure (growth of mold and bacteria). These lines indicate that this crack initiated at the site indicated.

Note: A crack arrest line is formed when a crack stops then starts up later. The stress that re-starts the crack is in a slightly different direction; so, during the re-start the crack changes direction and forms the line. In addition, the stresses that are driving the crack are applied stresses; they are not residual stresses from manufacturing.

The failure initiated first at the hole for the right hand hold down bolt. The final failure initiated at the right hand hold down bolt and at the center “drain” hole. The presence of the arrest lines indicate that the failure was caused by applied stresses. If it were the result of manufacturing stresses, the crack would have gone to completion once it was initiated.

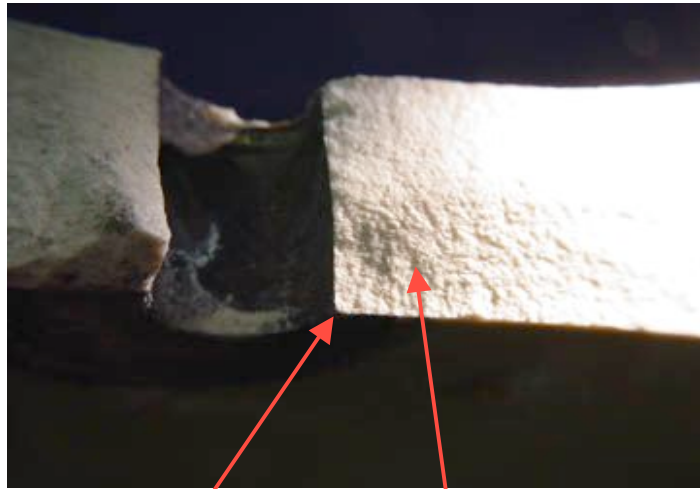
Crack Initiation Site

Crack Arrest Line

Figure #4: One view of the fracture surfaces at the right hand hold down hole. For this photo the light angle was chosen to reveal a crack arrest line from a crack starting on the inside of the tank and on the *left side of the hole*. The lack of staining shows that this crack started soon before the final failure, or, at least, it hadn't existed long enough to become stained.

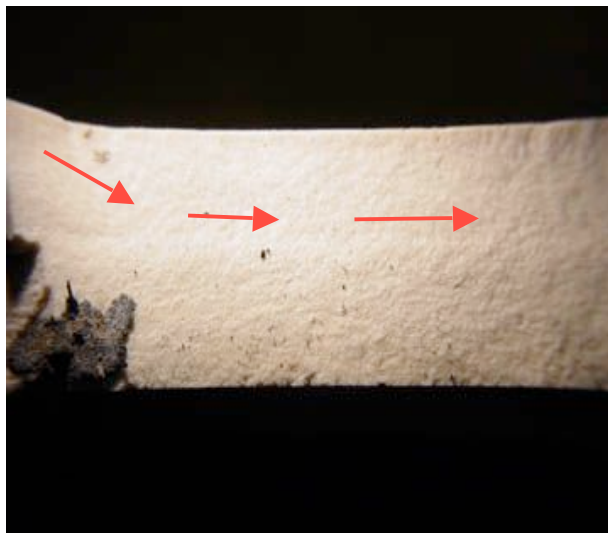
Figure #5: Fracture surface near the drain hole. The piece of pinched rubber is shown. In addition, there is no staining. The arrows show the travel direction of the crack. Note: The markings that indicated the crack travel direction are very faint. This crack started on the inside of the tank at the edge of the holes.

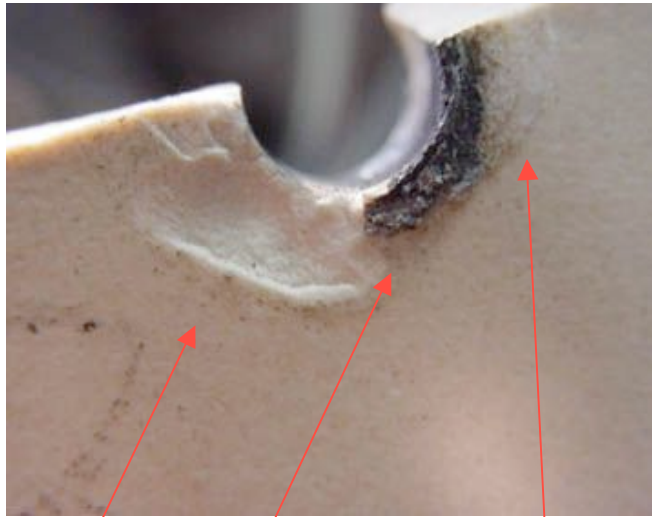
“Crush Damage” Rubber? Wear from Metal from Washer

Figure #6: Close up of the damage around the right side hole for the hold down bolt. This damage consists of crushing and digging in from a washer tightened against the bottom of the tank. In addition, there is evidence that part of a rubber washer was present.

This tank was in service for over 13 years. In addition, it shows evidence that there were long term cracks and leaks. It is my opinion that this tank has seen a lot of “wear and tear”. In addition, the evidence of damage around the hold down holes on the outside of the tank indicates that this toilet was not assembled according to the manufacturer’s instructions. It appears that there were a nut and washer screwed up against the bottom of the tank. Also, there are signs that this assembly was over tightened. This tank failed as a result of handling damage; it didn't fail from manufacturing stresses.
